AL128 Low press alarm

SPRSUN

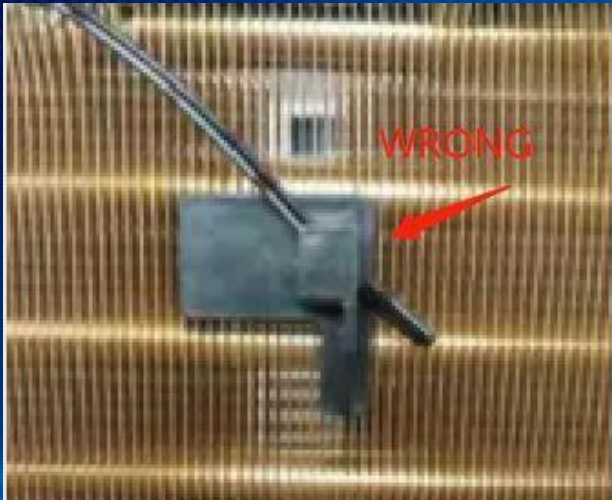
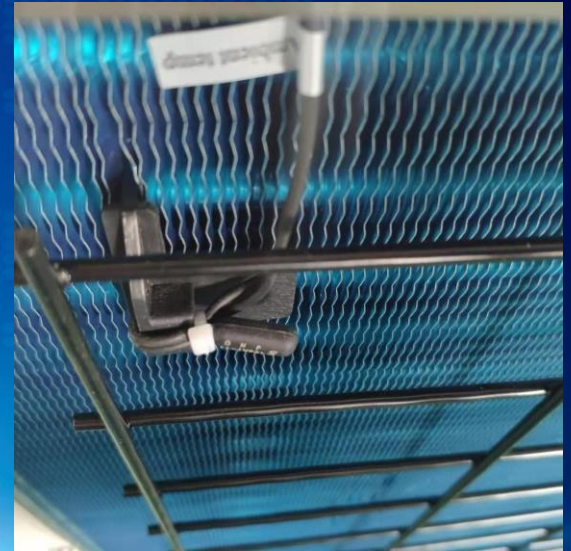
- The heat exchanger(Evaporator) is seriously frosted
- Bad blades result in insufficient air flow
- The low pressure sensor cables are loose
- System refrigerant leakage
- Low pressure sensor is broken

Heat exchanger frost serious: Need to make force defrost, and the environmental probe from the fin as far as possible to prevent being covered by snow, and check whether the defrost parameters have been adjusted, to maintain the original parameters
