AL013 Low superheat - Vlv.A

AL115 EEV alarm:Low superheat

SPRSUN

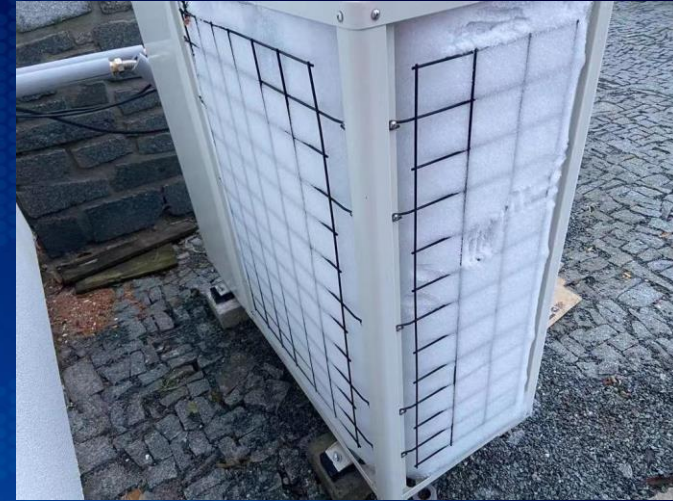
- The unit has heavy frost.
- The unit has been operating at low frequency for a long time.

- Visually check whether the unit is heavy frosted.
- Check whether the operating frequency of the unit in the user parameters is consistent with low frequency operation
